IIT RESEARCH INSTITUTE
Technology Center
Chicago, Illinois

SHELTER HABITABILITY IN EXISTING BUILDINGS
UNDER FIRE EXPOSURE

Thomas E. Waterman

June, 1966

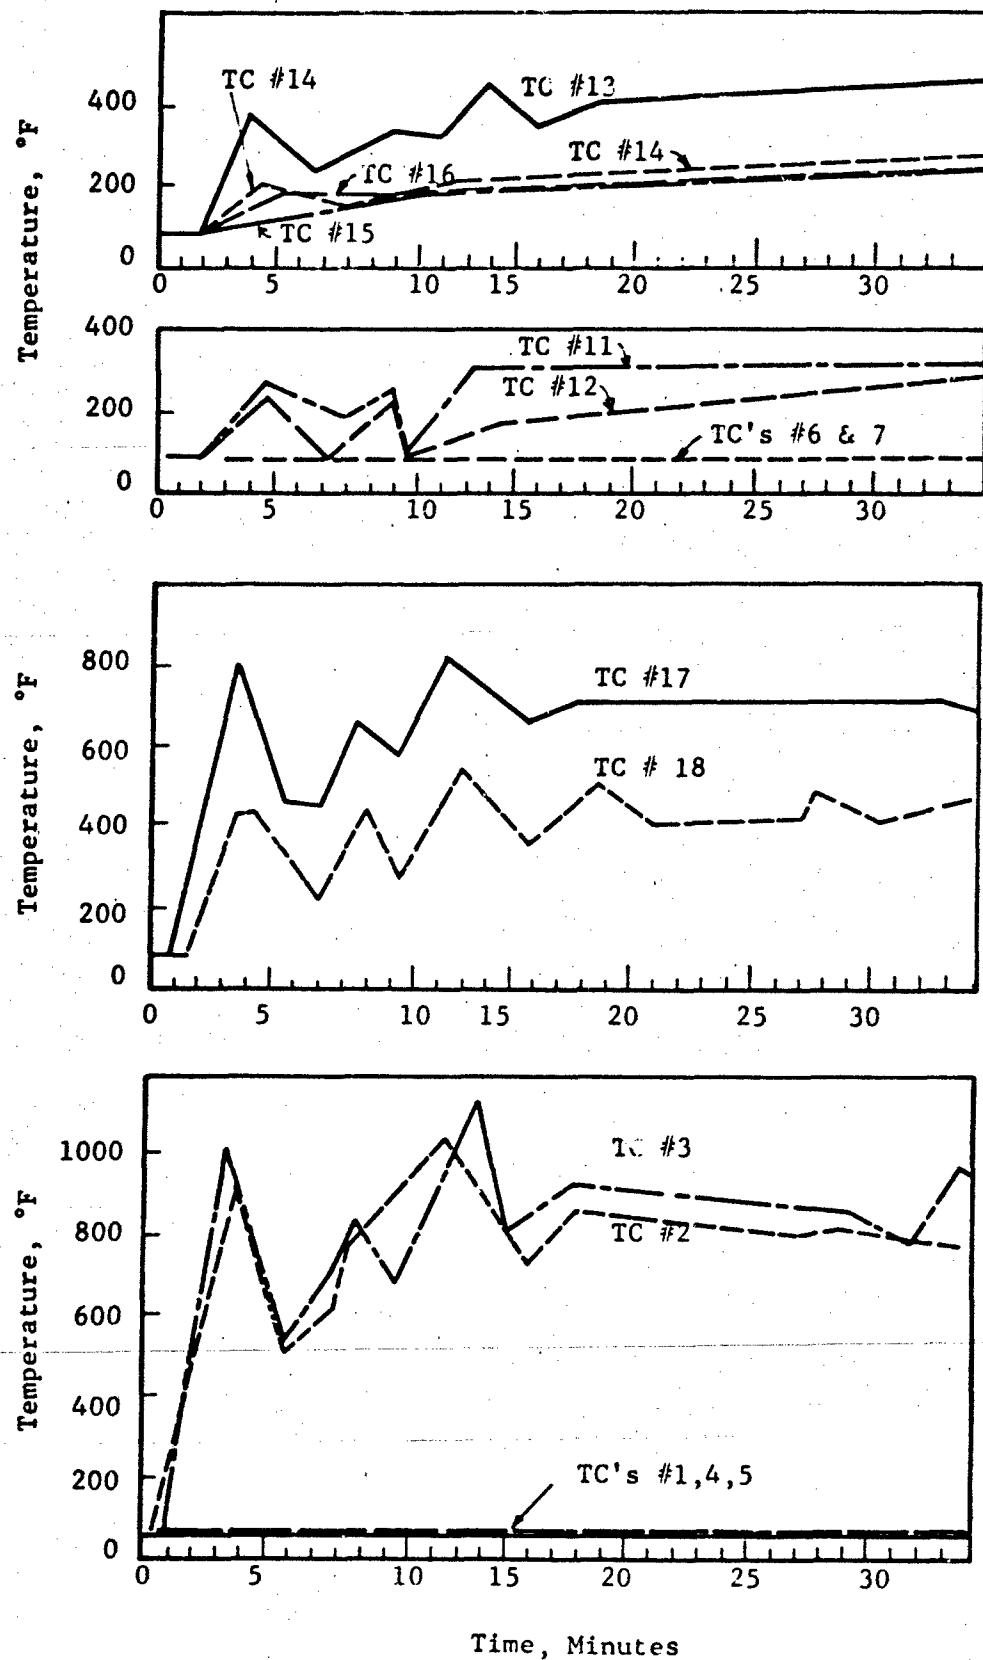
Figure 22. Temperatures, Building No. 2

A number of observations can be made from the data shown in Figures 20, 21 and 22. First, the fires did last long enough to permit all monitored points to reach an essentially steady-state condition. For example, Figure 20 shows that temperatures at points furthest from the fire (13, 14, 15 and 16) were essentially constant shortly after the peak temperature

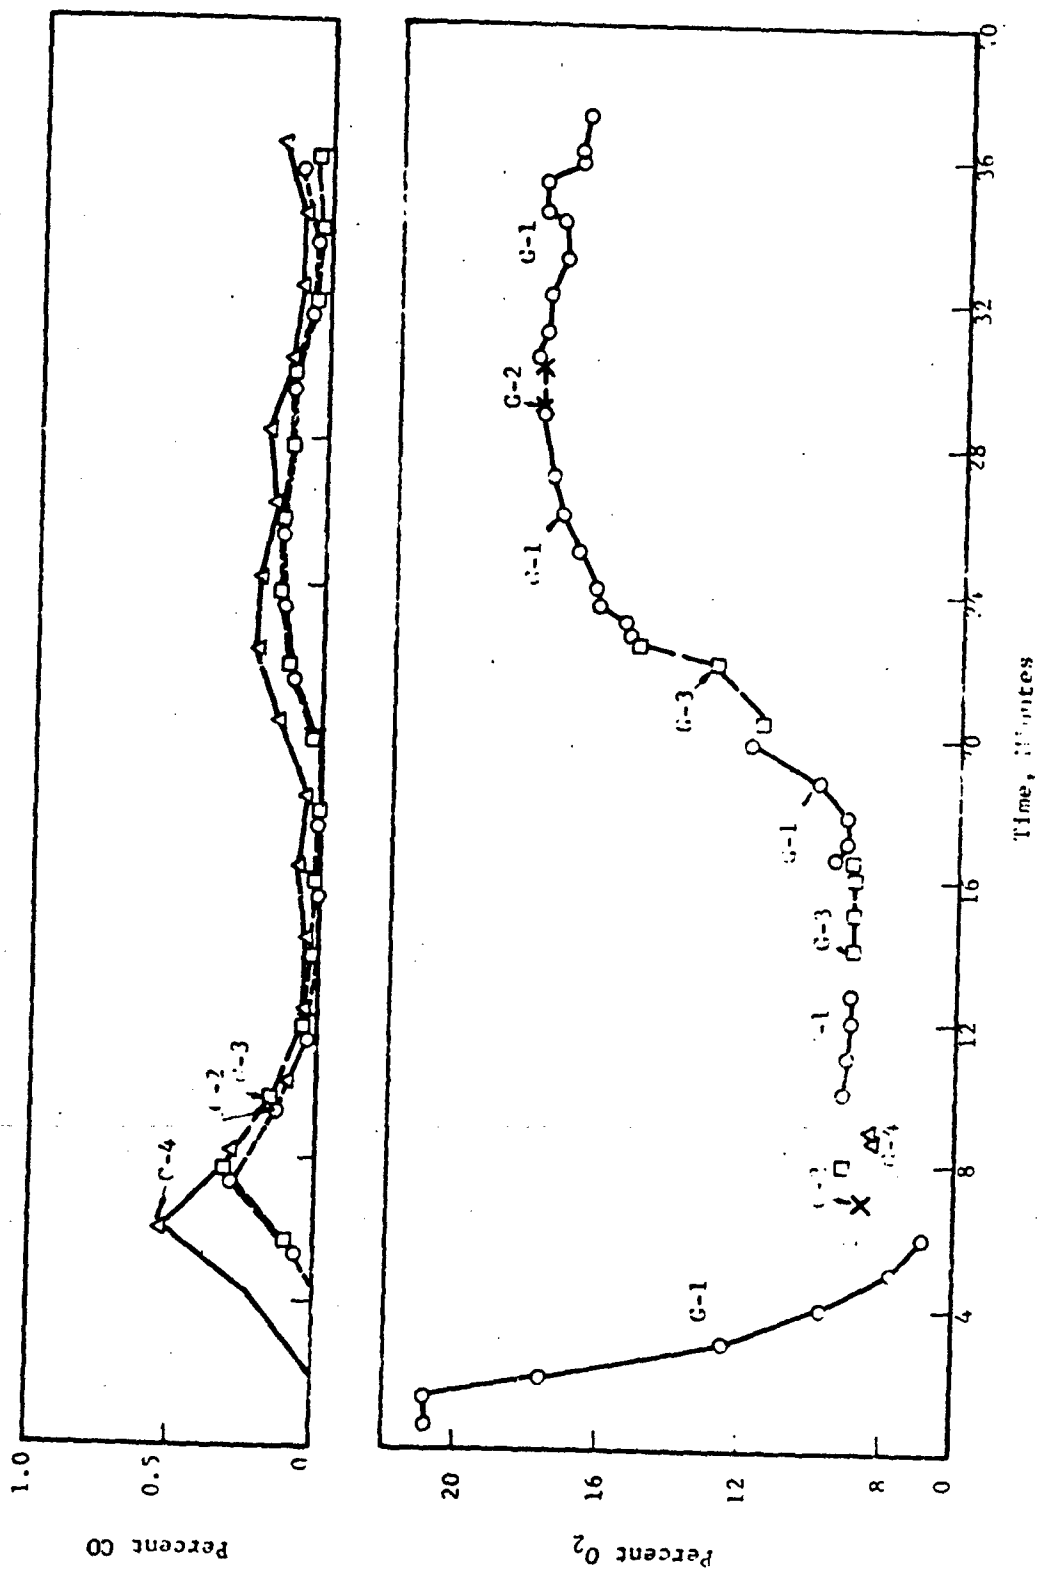
Figure 25. Gas Samples from Experiment 2, Building No. 1

Analyses from Experiment 2, Building 1 are shown in Figure 25. Data for CO concentration from Line 1 were lost

due to moisture collection in the line. The CO data from Lines 2, 3 and 4 were obtained with the total combustibles analyzer.

ances are made for these time intervals, it appears that very little change occurred in the CO content of any particular quantity of gas as it moved through the corridor and stairwell except close to the fire itself. It may be inferred that the same is true of oxygen content. Although the data on oxygen concentration are not complete, that shown in Figures 24, 25 and 26 tend to substantiate this inference.

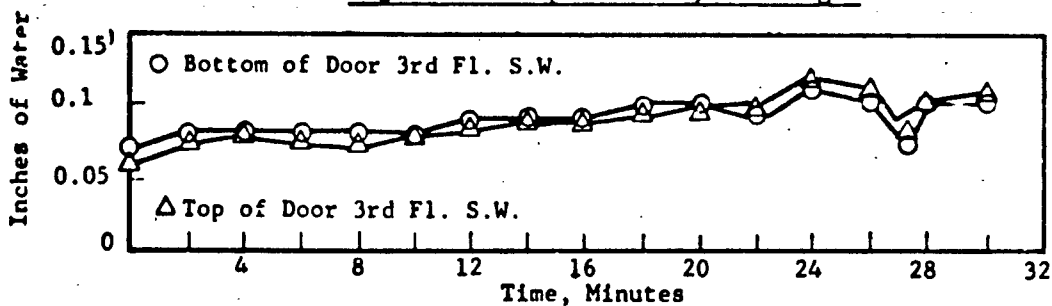
Figure 28. Experiment 1, Building

Pressure records are shown in Figures 28 through 31. Those for Buildings 1 and 2 were obtained by time lapse photography of the gauges and visual observation by fire department personnel. The data for Building 3 were recorded directly in the instrumentation trailer as described in Appendix A. A northeast wind impinged directly on the openings to the burn room of Building 1 and caused the pressure in the corridor-stairwell to be higher than that in other parts of the building. The wind was westerly during the burning of Building 2 so that the burn room windows were on the downwind side while the corridor and stairwell were on the upwind side. Leakages through cracks around other openings into the corridor-stairwell were sufficient in this case to

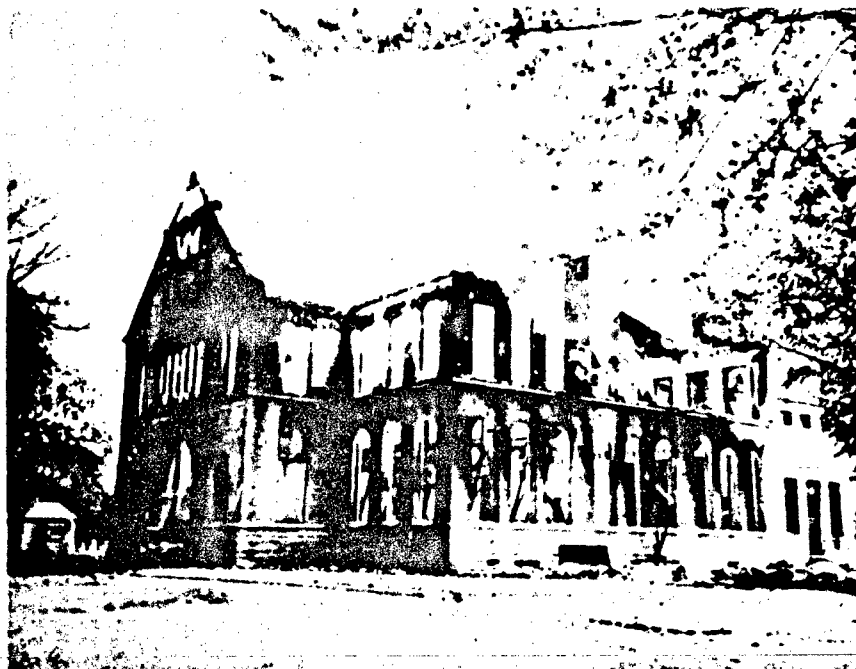
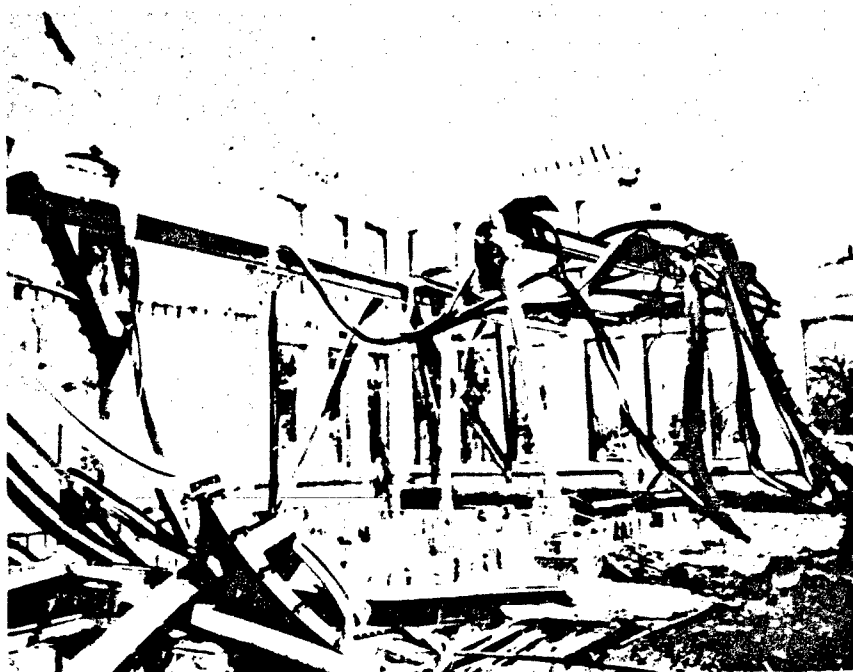
Figure 35. Building No. 3 after the Fire

Exterior northwest corner of building

Interior of dining hall

Due to their massive construction, only minor wall collapse occurred in Buildings 1 and 2. The same can be said of Building 3 except where the steel work used in the dining hall and auditorium areas weakened the walls (see Figure 35).

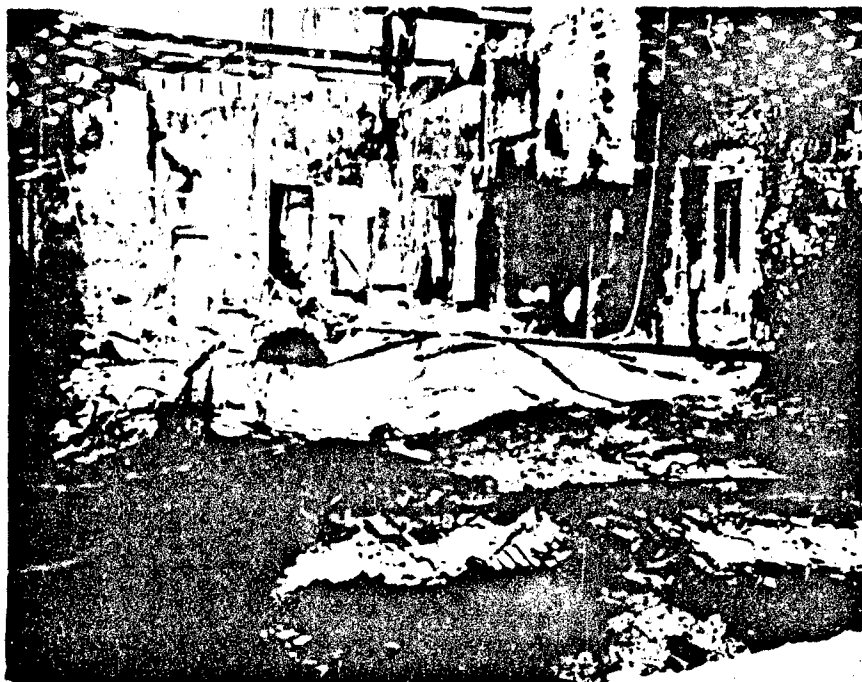
Debris above shelter (chimney
is back wall of shelter)

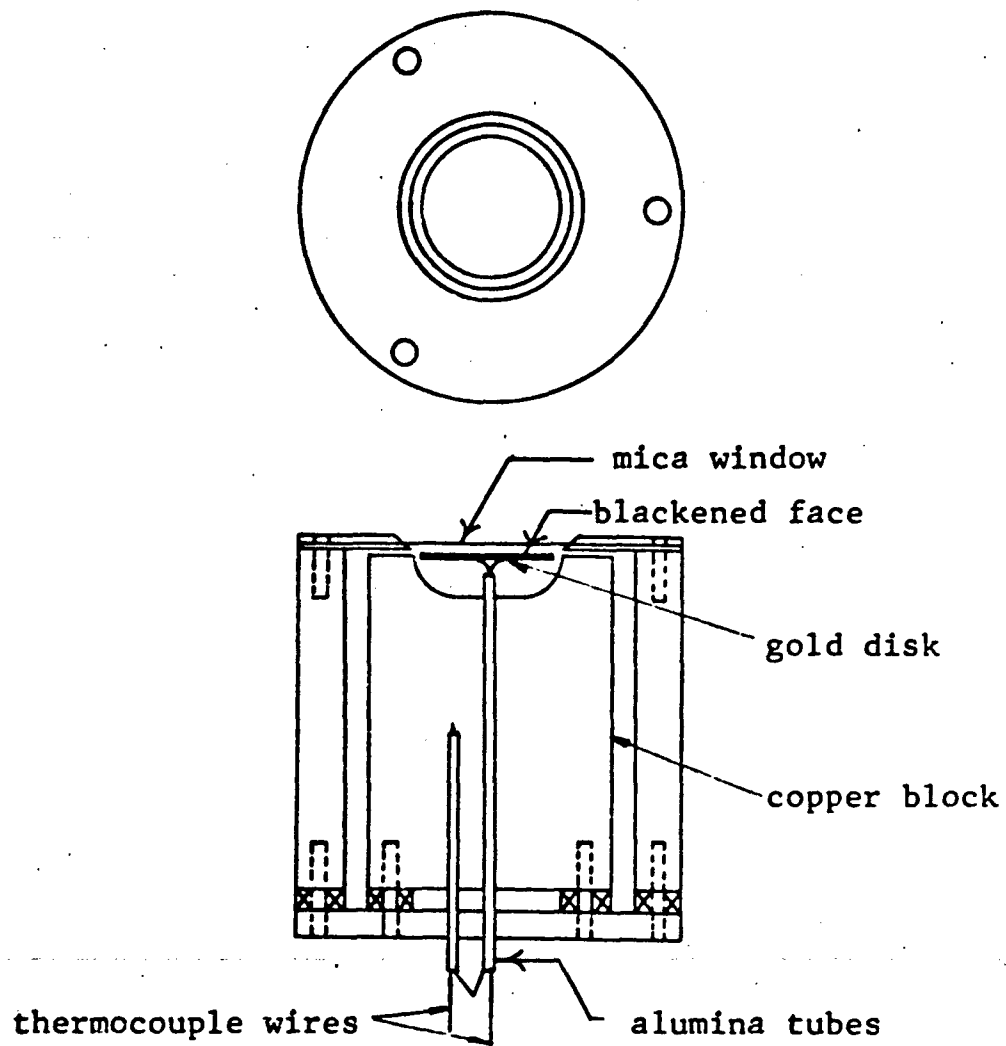
Figure A-1. Radiometer for Measuring Heat Flux from Fires

Note: Assembly screws
omitted for clarity

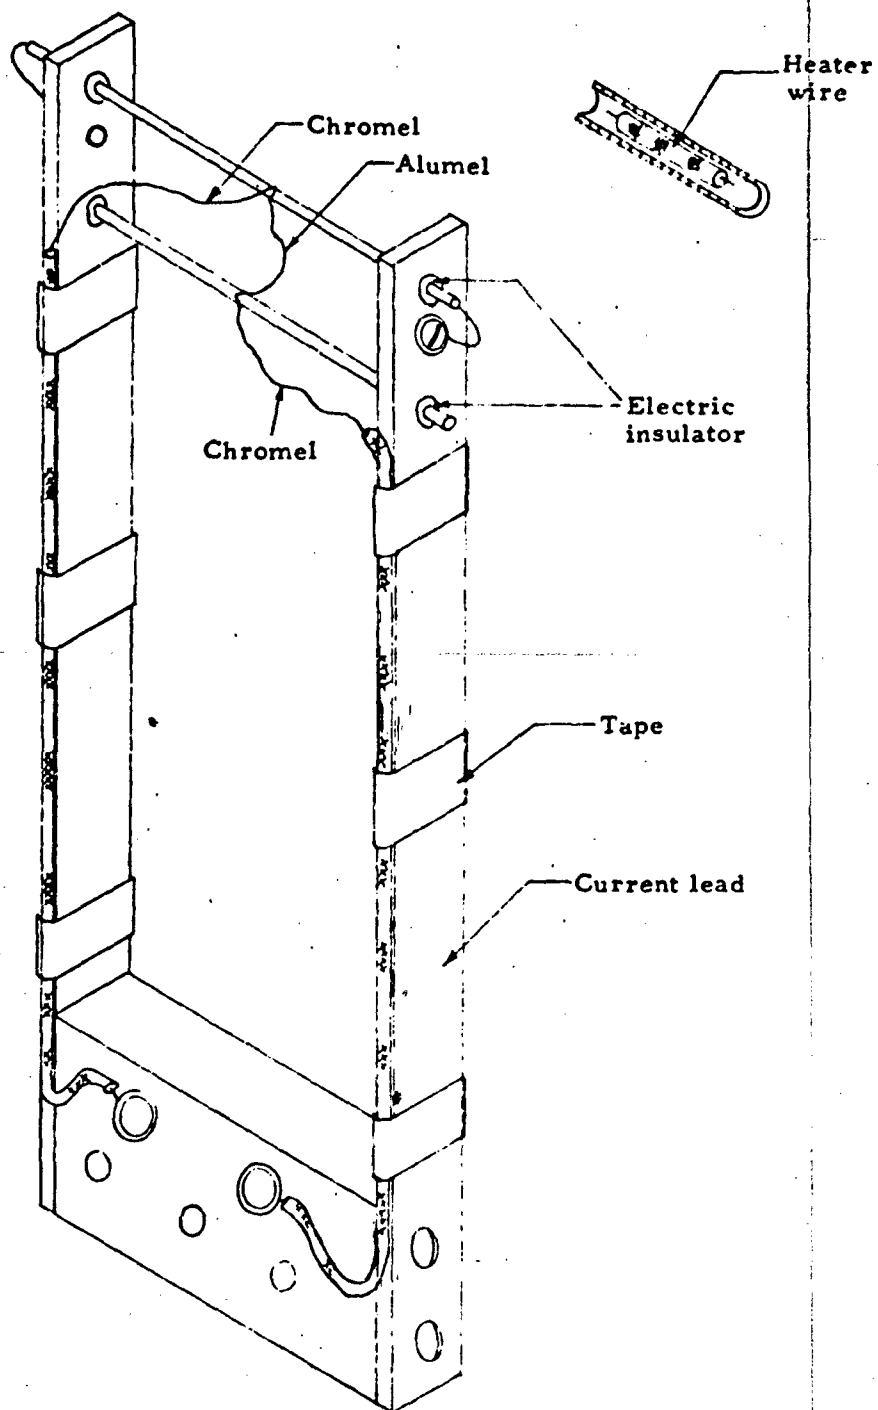
Figure A-4. Hot Tube Anemometer

Differential hot-tube anemometers based on the above design were constructed for the fire experiments and are illustrated in Figure A-4. The tubes of each unit were 0.042 i O.D. stainless steel, and the externally-connected differential thermocouple was made of 36 gage (0.005 in. dia.) chromel-alumel wires. One of the tubes contained an insulated 30-gage (0.010 in. dia.) constantan wire as a heating element, the supports serving as electric current leads. Heating of the resistance wire was recorded by monitoring the voltage drop. These hot-tube anemometers are of simpler construction than those described in Reference 10 and offer certain advantages. The use of a single hole metallic tube, instead of twin bore ceramic, assures uniform temperature around the circumference of the tube and thermocouples welded to the tube wall yield a more rapid response time. Gold plating and polishing the tubes reduces their emissivity with a

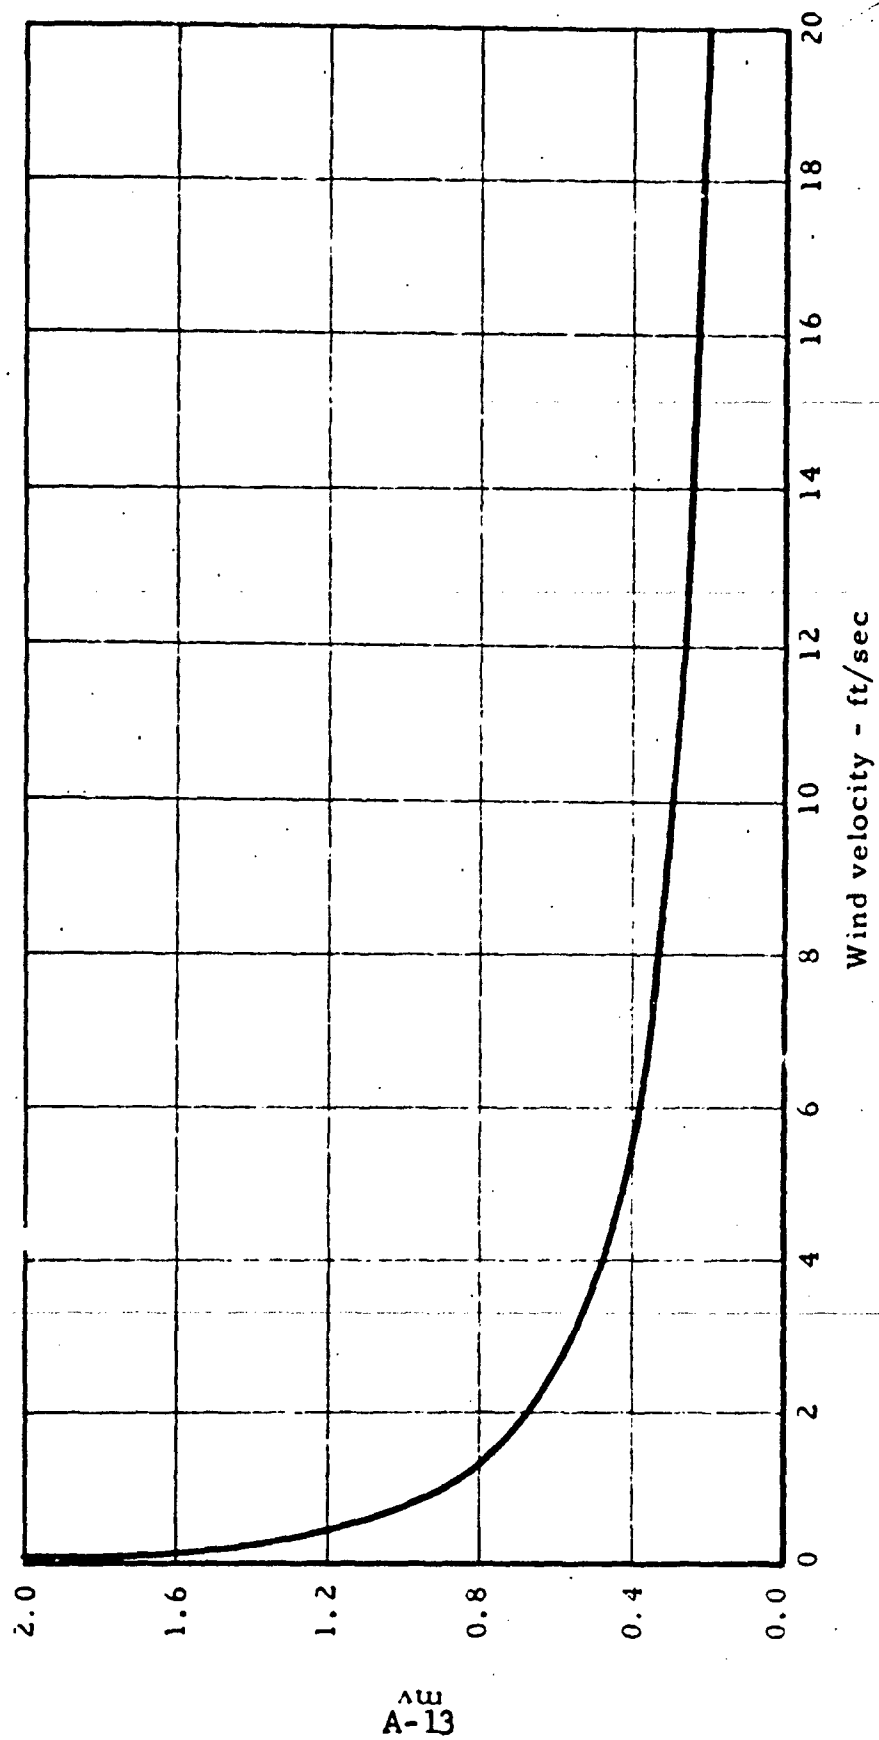
Figure A-5. Typical Anemometer Calibration Curve

As one might suspect, the calibration curve is quite sensitive to input current to the heated tube. A 100 per cent error was indicated in the wind velocity from a 15 per cent change of heater current. For this reason, the input current must be carefully monitored and controlled. To accomplish this and to minimize the number of controls required, panels were constructed which operated 1 to 10 anemometers per panel. The anemometers were connected in series through the panel and thus each received exactly the same current flow. A schematic diagram of a panel is shown in Figure A-6. Power was adjusted by means of a variable transformer and the approximate current level measured with a microammeter. To establish a precise, reproducible setting, a resistor was placed in series with the anemometers and, through a rectifier bridge, a D.C. millivoltage monitored. The conversion to a D.C. signal permitted the monitoring voltage to be read on the same recorder

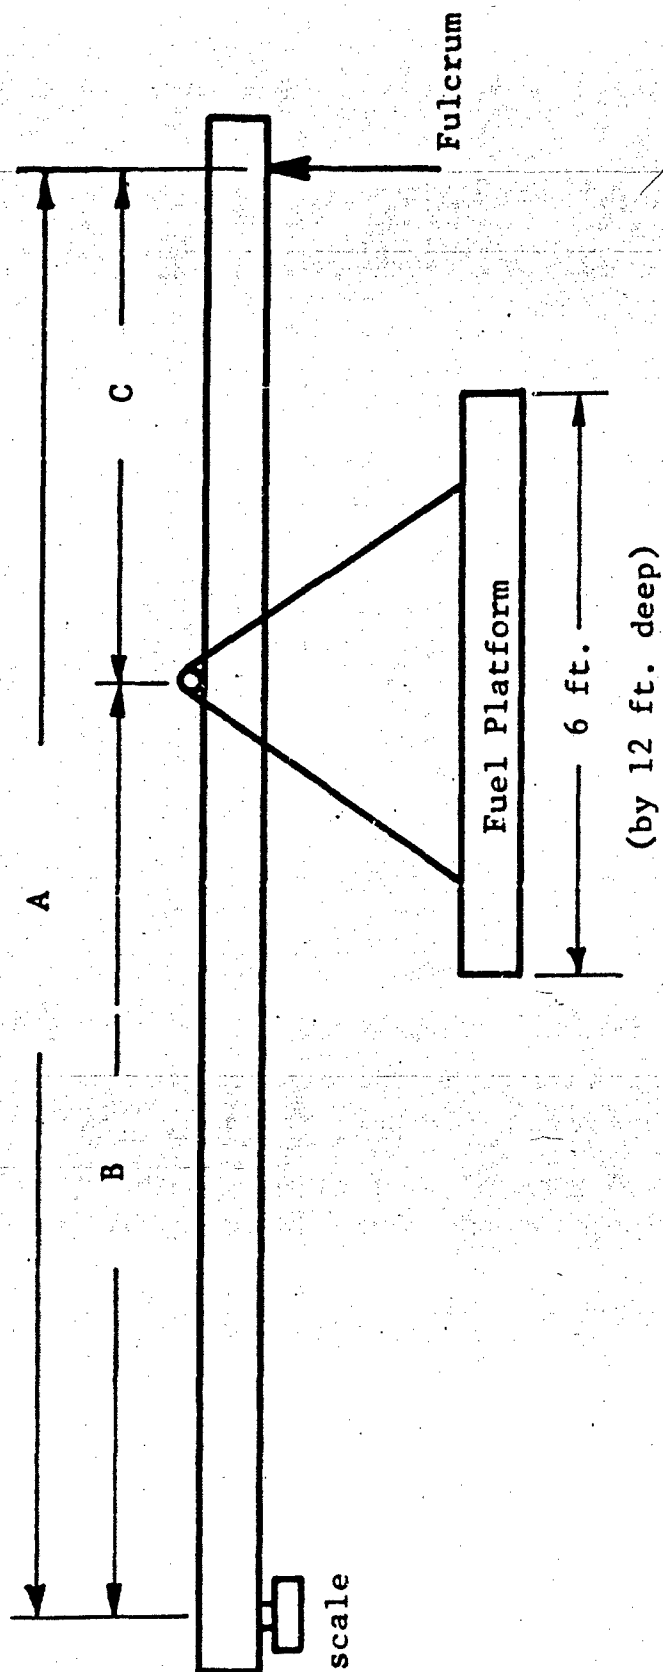
Actual Weight Loss = $\frac{A}{C}$ (sum of scale weight losses)

Building	A	B	C
1	181"	117"	64"
2	180"	120"	60"

Fuel loading in the room of origin consisted of a large wood crib (2 x 4 lumber) for each experiment which was weighed during the burn. (See Appendix A). The remainder of the structure was loaded with furniture to a typical residential condition in terms of the readily available fuels. No attempt was made to add those fuels which become available only in the later stages of the active fire such as closet contents and combustibles stored in dressers, chests and cabinets. Crib moisture content was between 9 and 12 per cent.
